The Bury, Rickmansworth, Hertfordshire

Completion of phase two conservation work

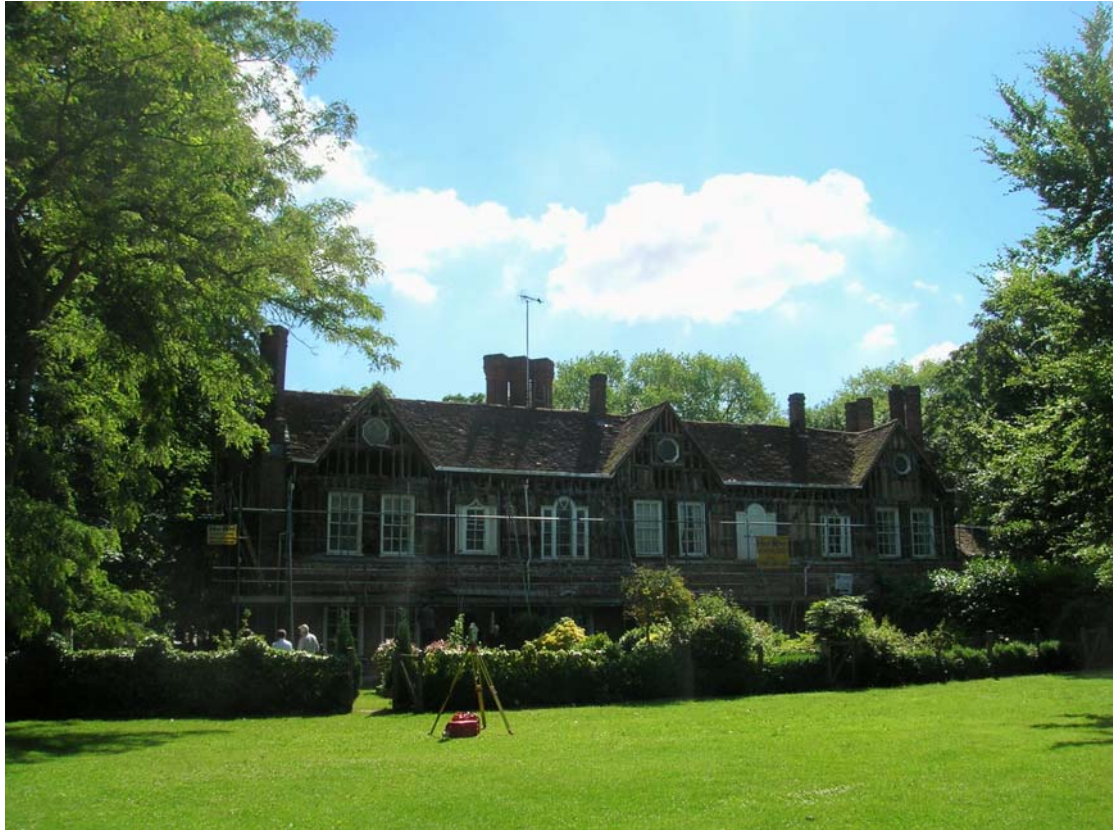
Recording the period timber frame during the phase two work

The external render consisted of pebble dashed render on chicken wire fixed to the period timber frame. This render was removed to expose a frame with extensive damage to some of the main timber members. The exposed framework was recorded by photogrammetry using large format cameras and laser scanning of the entire framework. The defective timber sections were removed back to sound timber, new oak timbers were inserted, where possible sound timber was refaced with new oak rather than wholesale replacement. Oak laths and breathable lime plaster finishes were then applied to the external walls and finished with coats of limewash. Cement render on masonry walls was also removed and replaced with lime render and limewash to allow the walls to breathe and release moisture externally.
