## The Priory, Rickmansworth, Hertfordshire

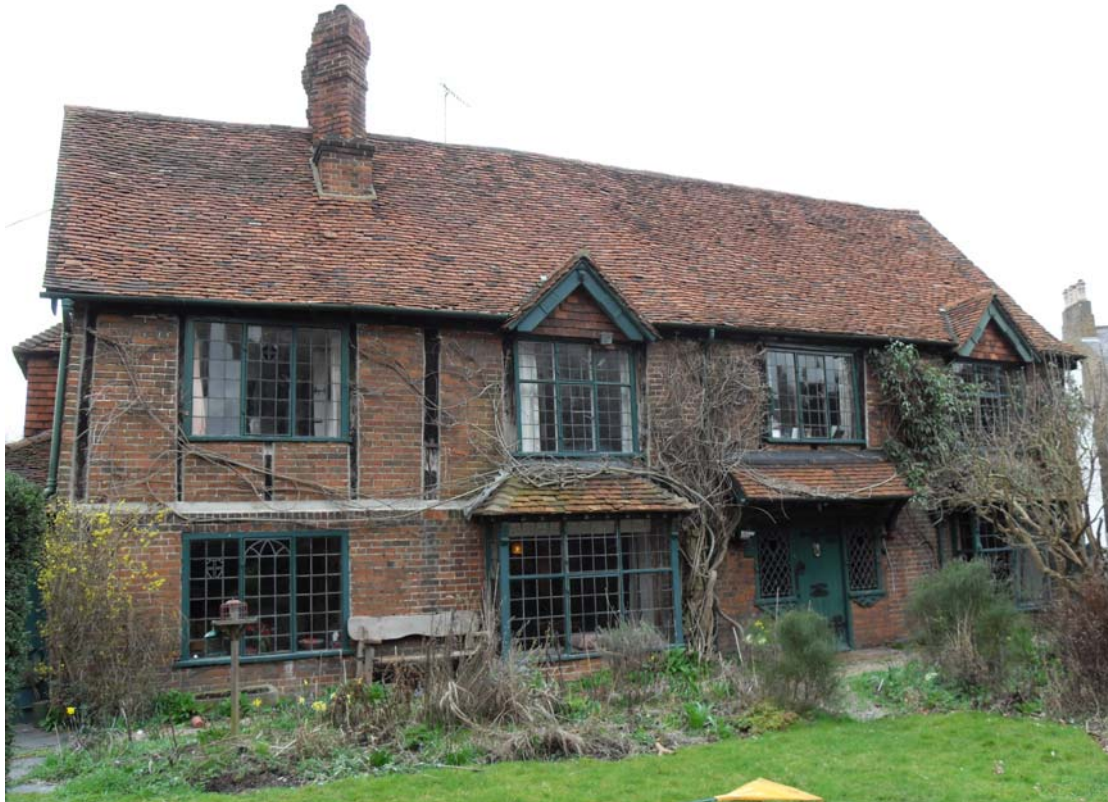
Front elevation before conservation work

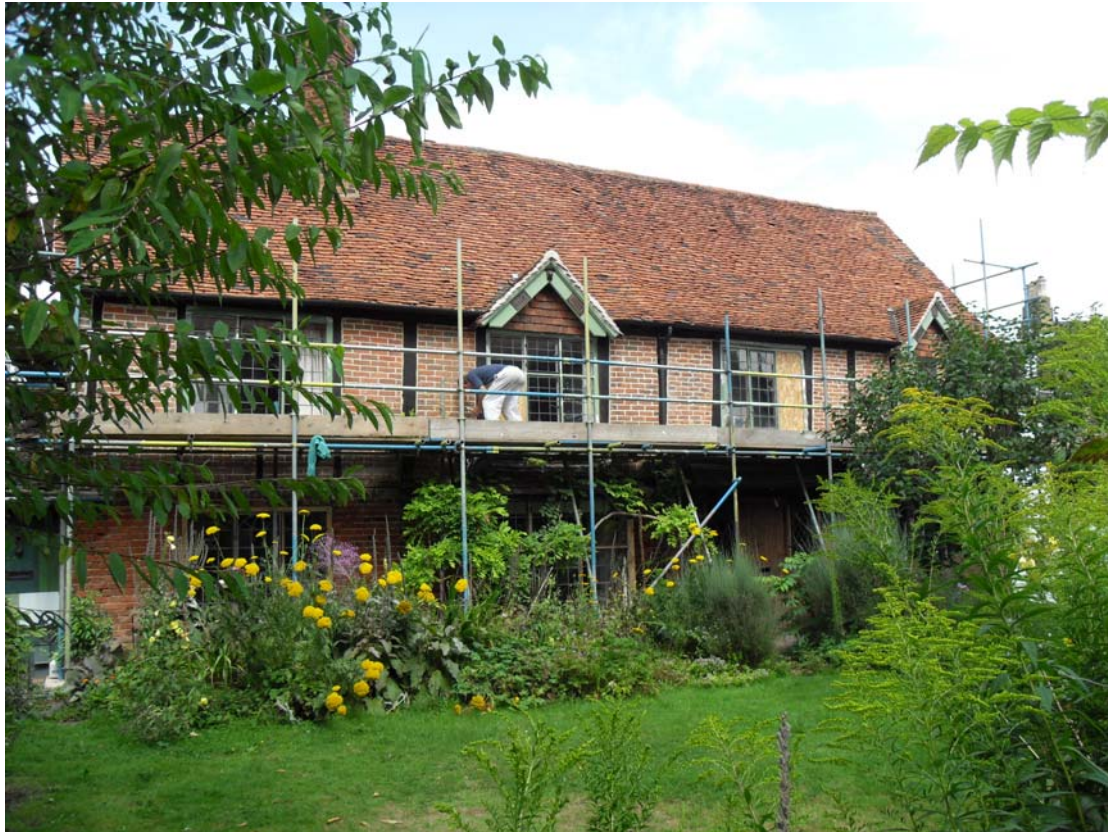
Front elevation repairs in progress

The following main areas needed to be addressed. Previous cement based repairs were preventing the building breathing properly leading to a damp and cold building fabric. The shallow pitched tiled roof coverings to the kitchen had been laid over a corrugated iron underlay. The rear porch was moving away from the main building and there were temporary repairs to the leaking roof coverings. The plumbing, heating and electrical services were very dated and at the end of their design life. Many walls and ceilings had been lined internally with modern fibreboard, hardboard or plasterboard to conceal dampness or replace defective lath and plasterwork. The windows, leaded light glazing and external doors were in a poor condition. A small 1930's asbestos garage was in a poor condition and restricted rear access and parking; this was removed and a rear parking area provided ready for the new garage.

The main works to the exterior of the building included removing all cementitious materials, repointing solid walls and repairing and repointing brick infill panels, all with lime mortar. Rainwater goods were overhauled and improvements made to surface water drainage. The external detail at first floor level was altered to prevent water from becoming trapped behind impervious finishes resulting in timber decay. Windows and external doors were repaired. Defective metal window frames were removed repaired and reinstated. Most leaded light windows were removed, overhauled, releaded and reinstated. The black paint was removed from the exposed timber framework and replaced with a breathable linseed oil applied hot. Modern plastic paint was removed from all external joinery and all surfaces repainted with breathable linseed paint.

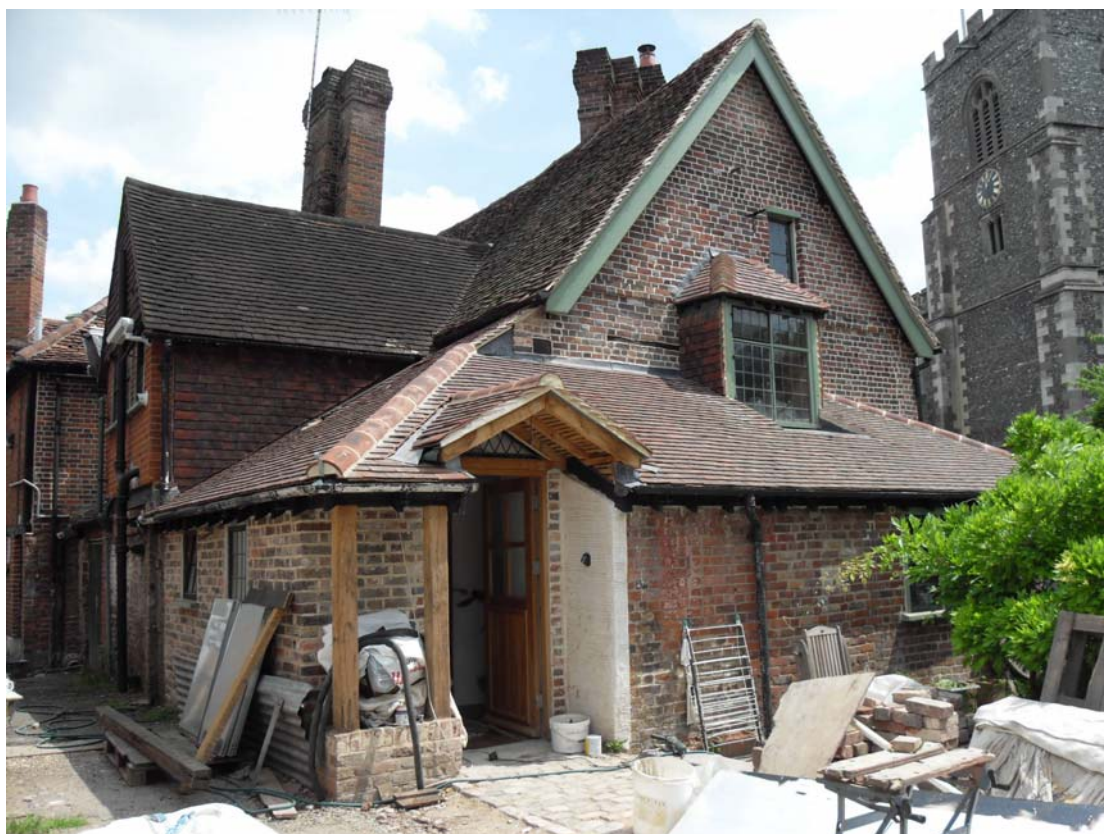
Alterations to the kitchen and utility area nearing completion

The kitchen and rear porch were late Victorian additions and were generally in a very poor condition. The pitch of the kitchen roof was too shallow and the roof covering had previously been stripped and relaid over corrugated iron metal sheets. Repairs and alterations to this area consisted of removing the defective rear porch structure; extending the building to form a new porch / rear entrance hall; converting the former coal store into a utility area with shower room and providing a link through to the rear entrance lobby and kitchen. The new utility area and kitchen were reroofed and the pitch of the kitchen roof was increased. The first floor bay window roof was recovered including replacing the leaking cement mortar flashings with stepped lead flashings.

Limecrete floors finished with traditional quarry tiled flooring were provided to the kitchen, utility and entrance hall areas. A brick infill panel was removed to form a new enlarged hatch opening between the kitchen and adjoining dining room. Additional insulation was provided to the lower roof areas and traditional lime materials were used for all repairs, alterations and finishes. The kitchen was refitted with modern units and appliances.
