High Street, Eaton Bray, Bedfordshire

High Street, Eaton Bray comprised the remaining section of a considerably altered 16th Century building together with 18th Century and 19th Century rear extensions. The building is not listed and very little is known of its history and development, however many answers were revealed during the recent building and conservation works.

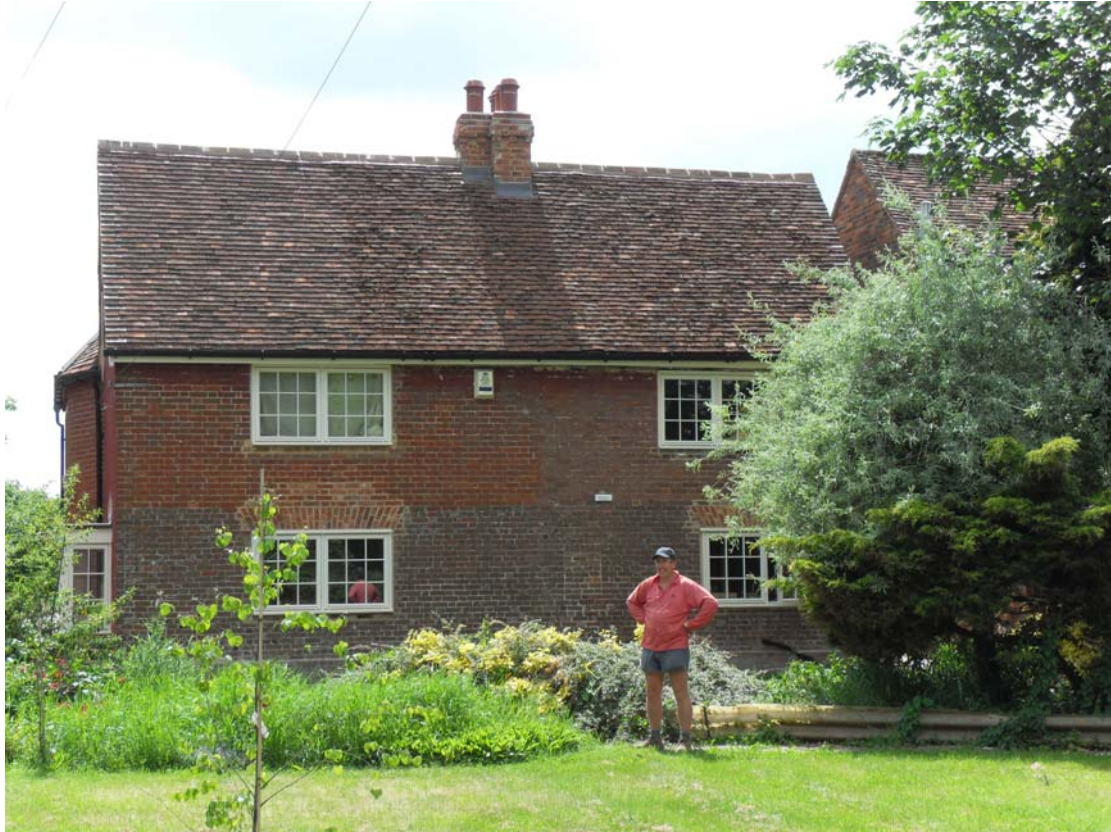
Front of the finished project viewed from the road

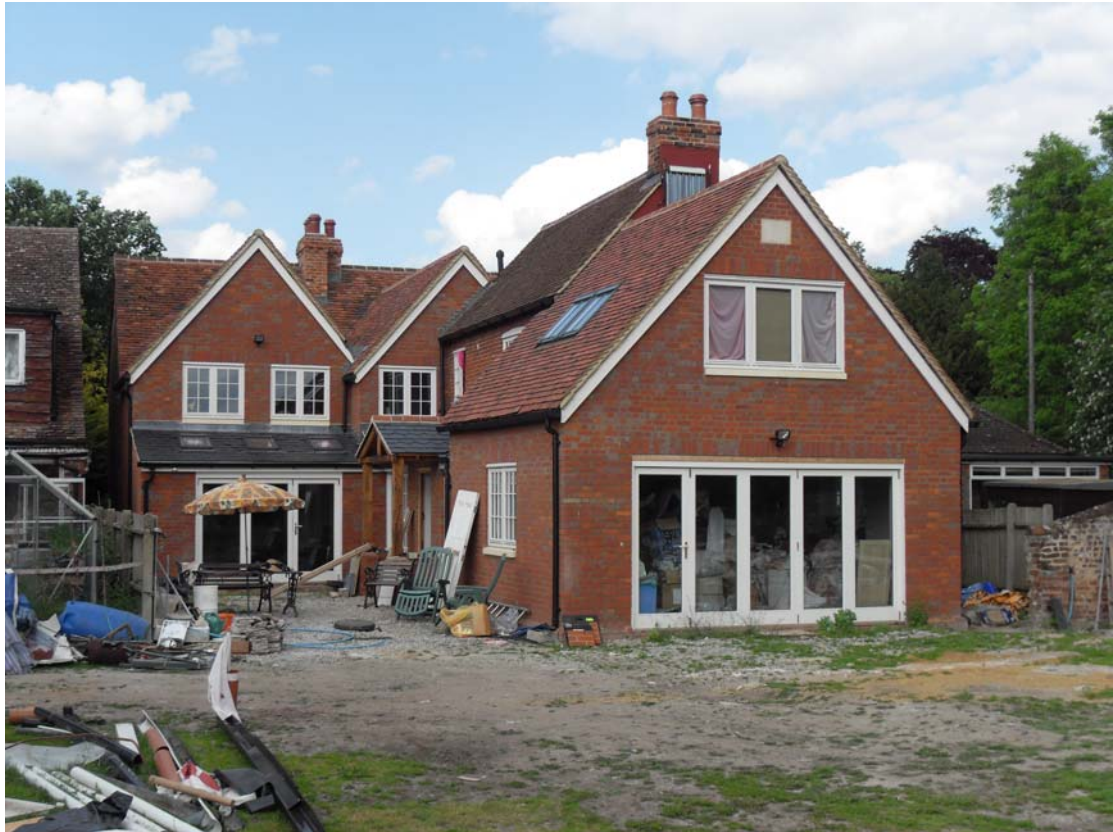
Rear extensions nearing completion

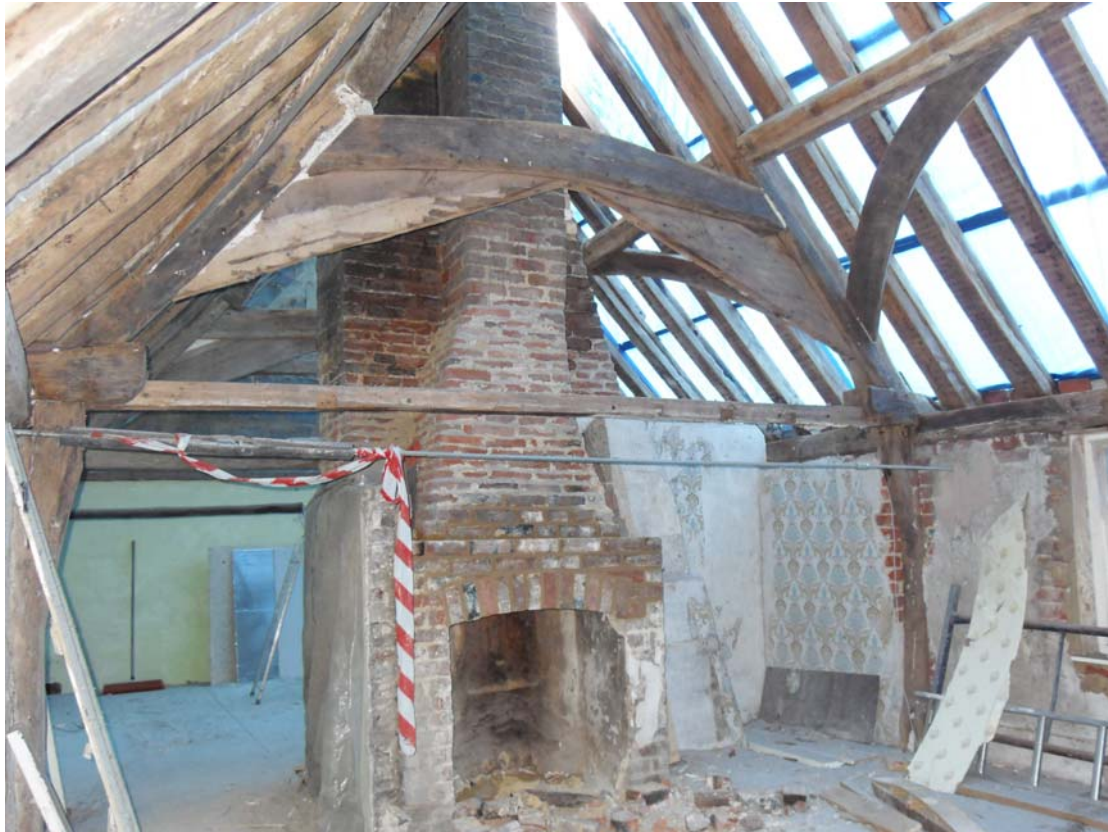
Remaining period timber framed roof structure

This 'Wealden' house was originally of three bays including a central open hall. The side bays had jetty / projecting first floors to the front. The roof had king struts braced downwards to the collars with long, straight braces and clasped purlins. There were closely spaced vertical studs to the first floor front and side suggesting a higher status building. The rear wall was square framed with an original outshoot with catslide roof behind. The walls had wattle and daub infill panels and the roof was thatched. An ornately moulded diaphragm beam identifies the high end and painted designs remain on many of the timbers at this end. There was a front and rear door to the central hall and a rear door to the first floor chamber in the left hand high end.

The building has been altered and its use changed over time. A large central chimney stack was built into the central hall which became a commercial food preparation area. The roof tie beams were cut out back to the jowl post positions. A further attached chimney stack was added to serve the first floor bedroom. Later, the large chimney stack was partially demolished, a partition added and a small fireplace inserted.
